# Carson River Special Dissolved Oxygen and Temperature Monitoring Project - 2005

*A supporting document for the Carson River Report Card*

**March 2006**

Prepared by:  
Randy Pahl  
Nevada Division of Environmental Protection  
Bureau of Water Quality Planning

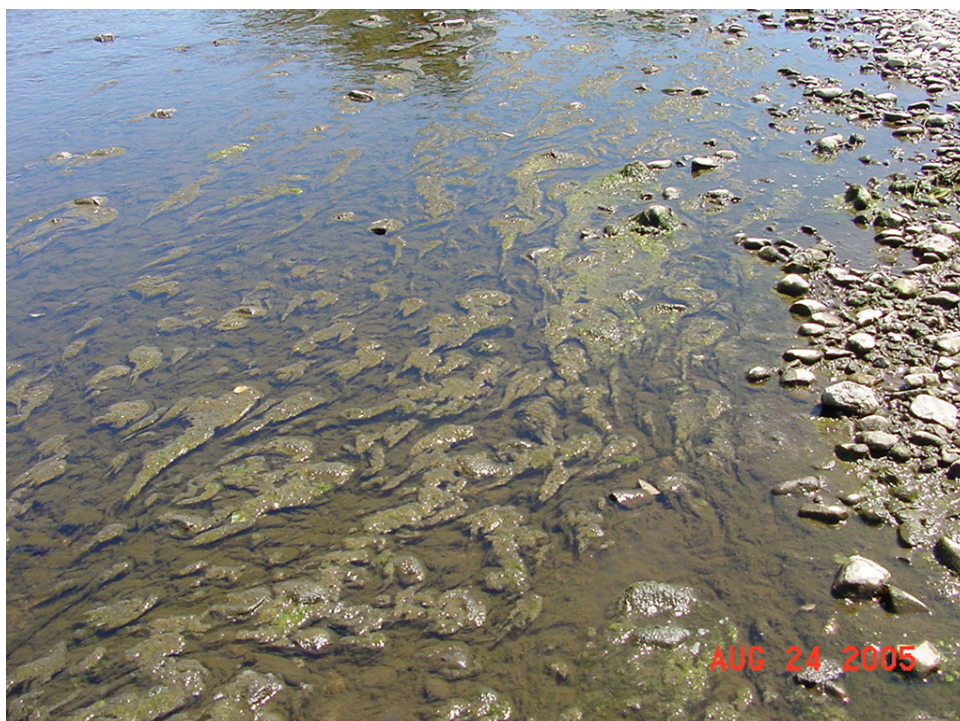
**East Fork Carson Results:** Of the three locations monitored on the East Fork Carson River, only the Muller Lane site experienced DO levels below the water quality standard with a low of 3.7 mg/l. By late August 2005, the algae growth just upstream of Muller Lane had become significant (Figure 5) resulting in the low early morning DO levels. During the 2001 monitoring project (Pahl, 2002), even thicker algal mats were observed with DO levels below 2 mg/l.

**Figure 5. Algae in the East Fork Carson River – between Highway 88 and Muller Lane – Late August 2005**

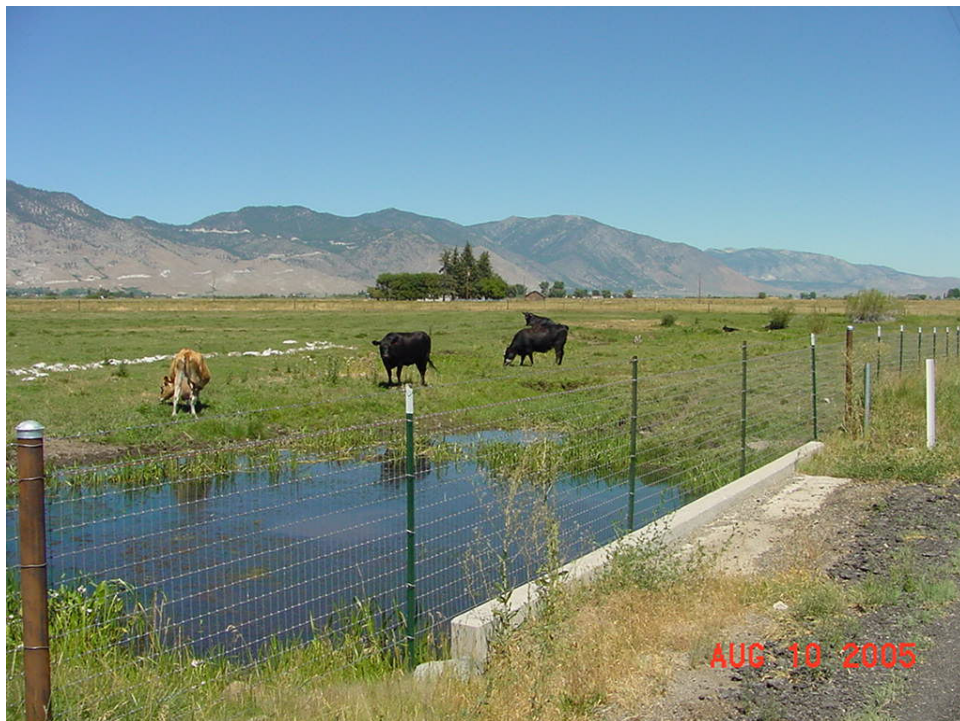
**Figure 6. West Fork Carson River at Highway 88 – August 2005 (looking downstream)**

**West Fork Carson Results:** Frequent DO standard excursions were measured at three of the four WF Carson sites: Centerville Lane, Mottsville Lane and Muller Lane, with the lowest levels at the Centerville Lane site. As described earlier, the flows of the West Fork Carson River are “re-directed” into the Brockliss Slough leaving very little flow in the West Fork at this point (Figure 6). Below this point, the West Fork Carson River channel conveys East Fork Carson River water for irrigation and also serves as a catchment for return flows from land irrigated with East Fork Carson River water (Hess, 1996).

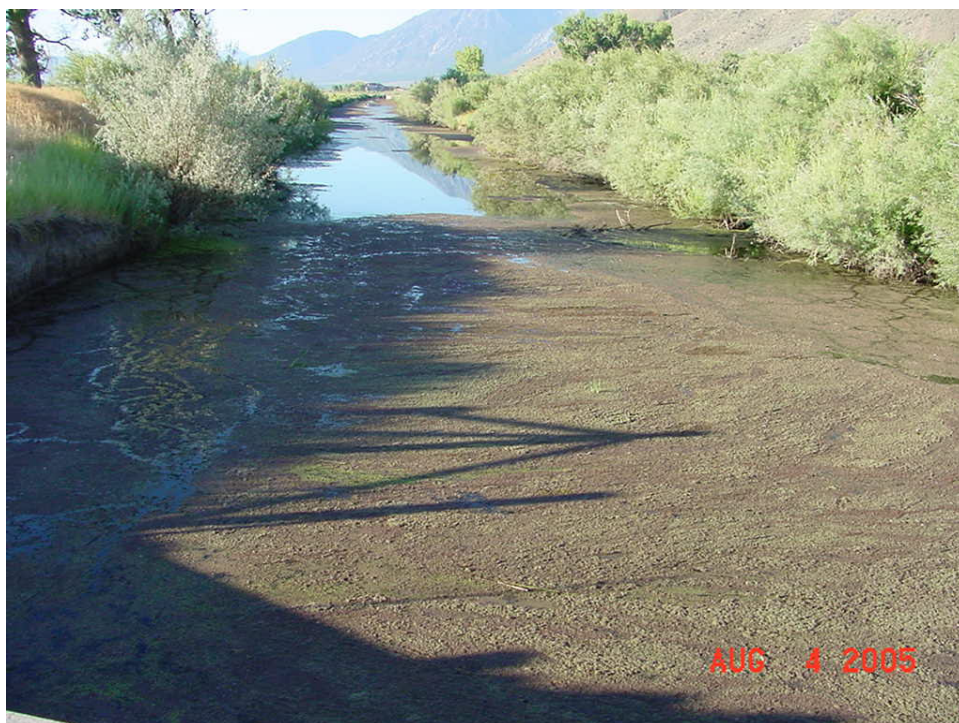
**Brockliss Slough Results:** DO standard excursions frequently occurred on the Brockliss Slough branches at both the Muller Lane and Genoa Lane sites with the worst levels occurring at Genoa Lane. This is not surprising considering the stagnant conditions and extensive aquatic plant growth at Genoa Lane (Figures 7, 8).

**Figure 7. West Branch Brockliss Slough at Genoa Lane – August 2005 (looking upstream)**

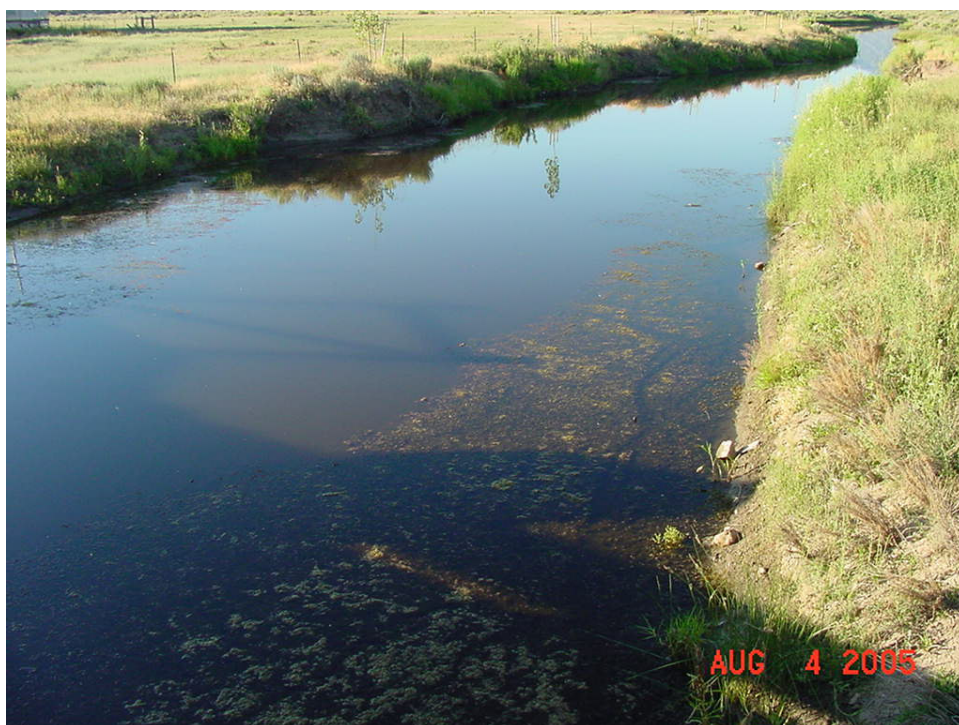
**Figure 8. East Branch Brockliss Slough at Genoa Lane – August 2005 (looking upstream)**

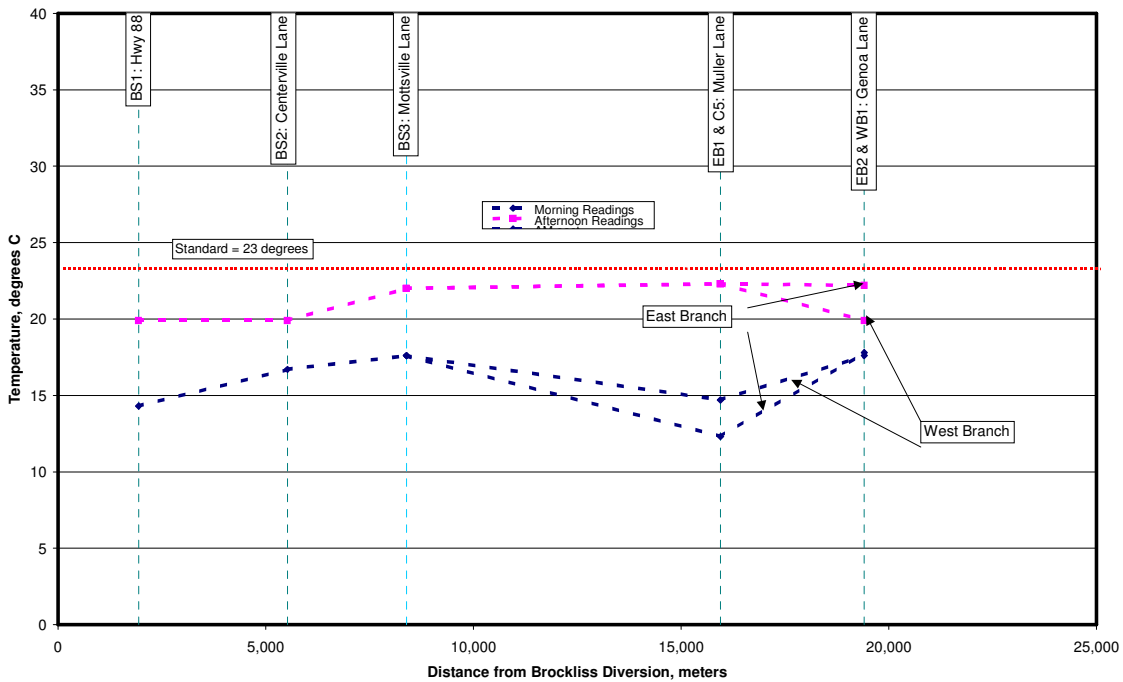
Figure D-6: Brockliss Slough - Temperature, 8/4/2005

Figure D-7: Brockliss Slough - Temperature, 8/10/2005

Figure D-8: Brockliss Slough - Temperature, 8/18/2005

Figure D-9: Brockliss Slough - Temperature, 8/24/2005

Figure D-10: Brockliss Slough - Temperature, 9/2/2005

High temperatures consistently occurred at the east and west branch sites on Muller Lane, and periodically occurred at the other locations.
