Carson River Special Monitoring Project - 2001

August 2002

Randy Pahl
Bureau of Water Quality Planning
Nevada Division of Environmental Protection
Department of Conservation and Natural Resource

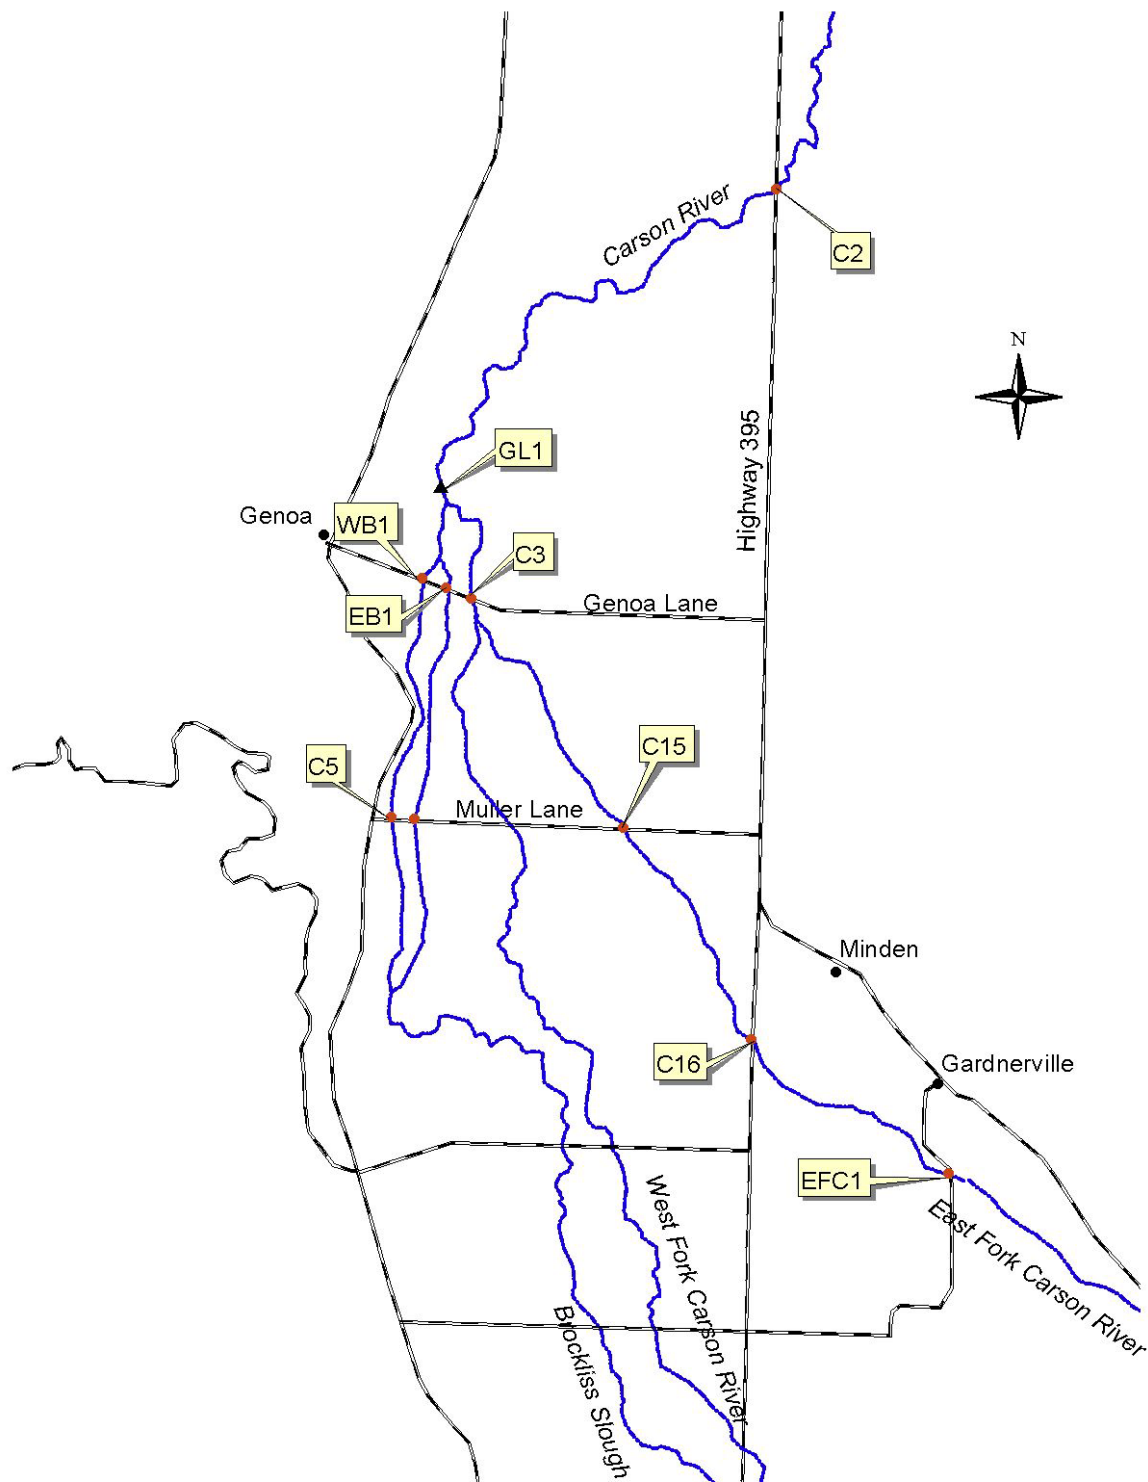
Figure 1. Water Quality Monitoring Sites

During the period July 6, 2001 through September 24, 2001, the BWQP performed intensive monitoring for a portion of the Carson River system in Carson Valley. Figure 1 and Table 1 present the main monitoring sites used during this project. On July 6, 2001, BWQP installed a Hydrolab DataSonde in the Carson River at the Genoa Lake Golf Course. The Hydrolab was used to collect hourly DO, temperature and pH values over the course of the study. Each week, data were retrieved from the Hydrolab and the unit was recalibrated. At that time, a water grab sample was taken and sent to the laboratory for analysis. Also, streamflows at the site were estimated by staff.

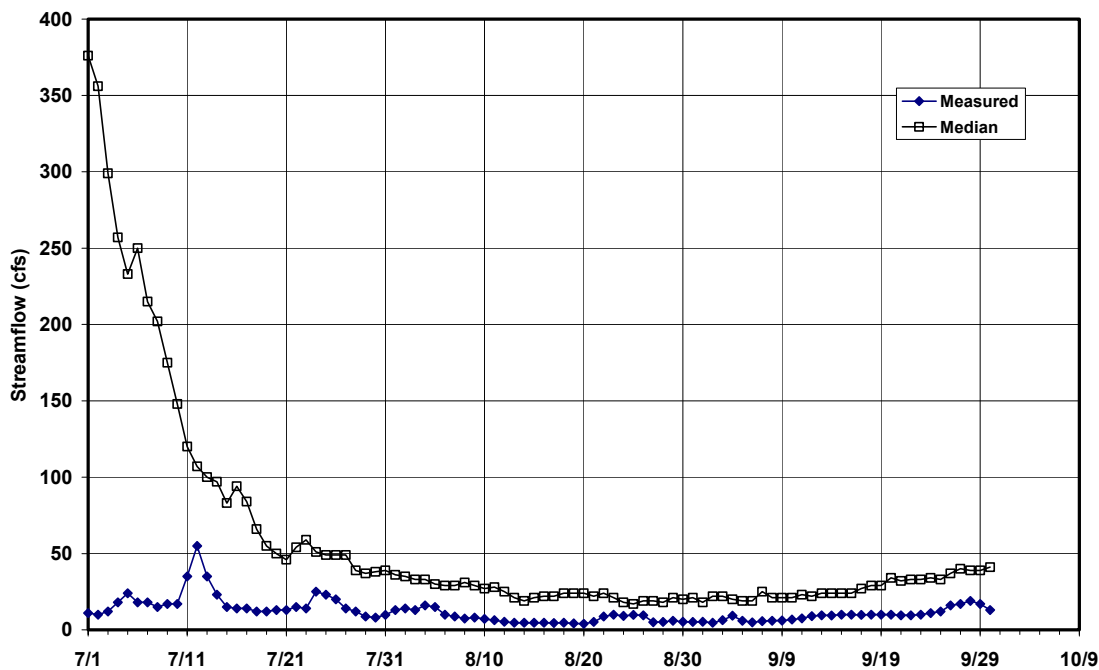
Figure 2. 10311000 - Carson River at Carson City, NV - Measured and Median Flows

Conditions during this project were extreme in terms of streamflow and weather. The 2001 Water Year was the driest and hottest on record. During the study period, streamflows at Carson River at Carson City were significantly lower than the historic median flows at this station, especially during the early part of the monitoring (Figure 2). Flows were approximately at the

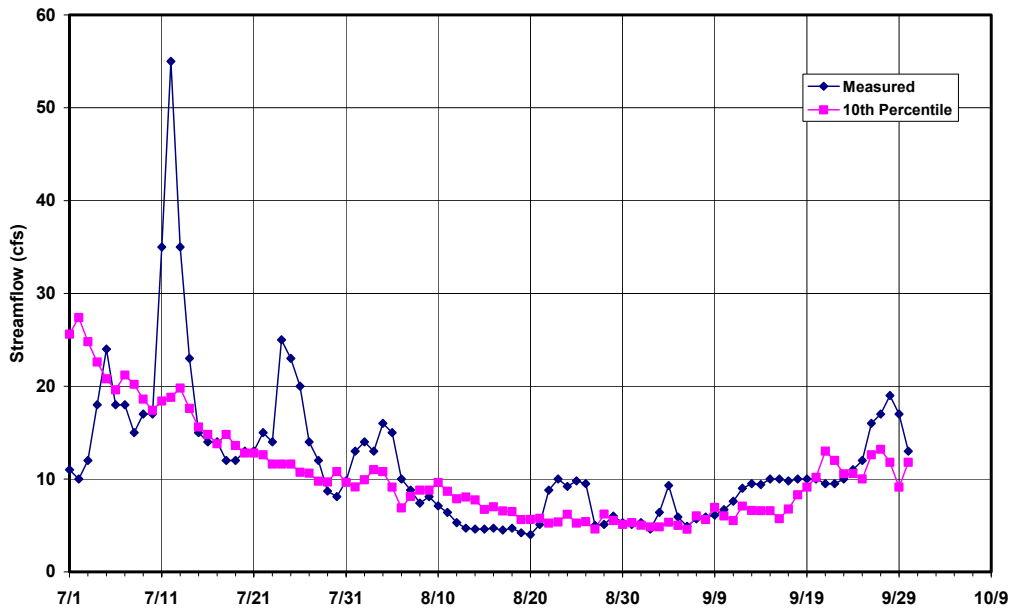
Figure 3. 10311000 - Carson River at Carson City, NV - Measured and 10th Percentile Flows

historic 10th percentile level (Figure 3). In otherwords, historic flows have been at these levels (or lower) for these days about 1 out of 10 years. Further exacerbating the low flow conditions, air temperatures were frequently hotter than normal (Figure 4).

Though Water Year 2001 was the driest on record, flows during the monitoring period were not the lowest on record. As shown on Figure 3, flows at Carson City have been lower than the July 7, 2001 through September 24, 2001 flows about 10 percent of the time. These lower flows have occurred during previous drought years such as 1977 and 1988. Based upon this information, it would appear that the data collected as part of this study are close to the $7Q10_{low}$ threshold and are borderline for evaluating water quality standards compliance.

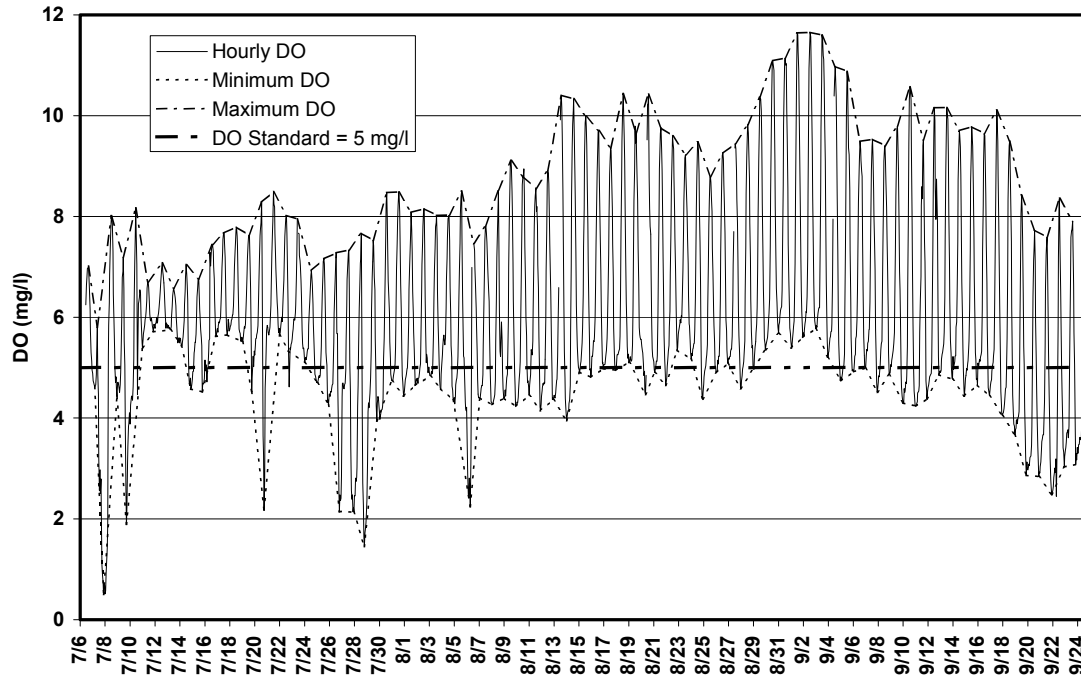
Figure 5. Carson River at Genoa Lakes Golf Course - Dissolved Oxygen

Hourly DO and water temperature data collected at the Carson River at Genoa Lake Golf Course site are summarized in Figures 5 and 6. When the Hydrolab was installed on July 7th,

As stated earlier, the water quality standard for dissolved oxygen for June through October is 5 mg/l (single value) at this location on the Carson River (See NAC 445A.153). During the 80-day monitoring period, most of the days (75%) experienced DO levels below the 5 mg/l standard for some period during the day (Table 2). However in many instances, the lower DO levels were of limited duration with only 29% of the hourly readings having DO levels below 5 mg/l. Exceedances of the standard were even less (14%) when the data were examined on an average daily basis.

There appears to have been quite a lot of instability in the diurnal DO patterns during the first two weeks of the monitoring. It is believed that some of these erratic fluctuations in the DO and temperature occurred as the result of weather systems passing through the region. As discussed above, the initial Hydrolab site was experiencing limited flow movement in the days prior to August 6. Some of the erratic fluctuations in the data may have been caused by this condition. It may be that the data collected after August 6 are more reliable and indicative of conditions in the main stream. However it must be noted that the Hydrolab was installed near the river bank and the data may not be representative of conditions across the channel cross section.

It is interesting to note that after August 6th most of the minimum DO levels were near the 5 mg/l level. However during the last week of the monitoring, the minimum DO levels dropped to below 3 mg/l. This drop seems to coincide with an increase in total nitrogen, nitrate and phosphorus levels on 9/24/01 (see Table 3).

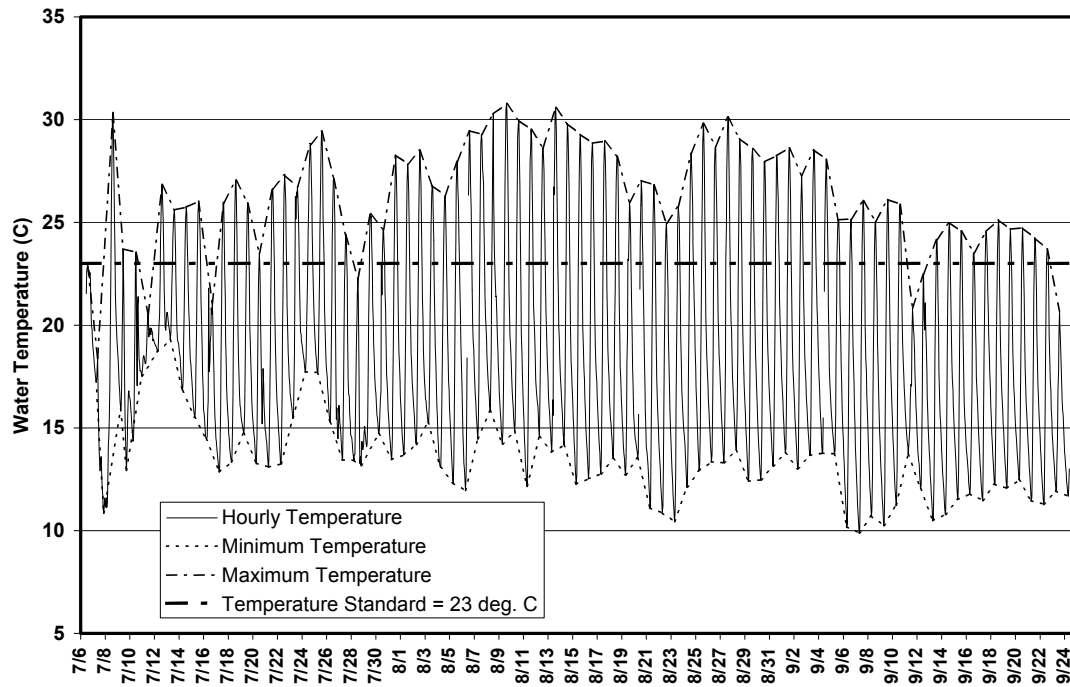
Figure 6. Carson River at Genoa Lakes Golf Course - Water Temperature

The temperature standard for July through October is 23 degrees C for this reach of the Carson River (NAC 445A.153). Over 90% of the monitored days experienced water temperatures higher than the 23 degree C standard. Only 22% of the hourly readings had temperature levels higher than the standard. When the temperature data were averaged for each day, none of the daily average values were over the 23 degree C standard.

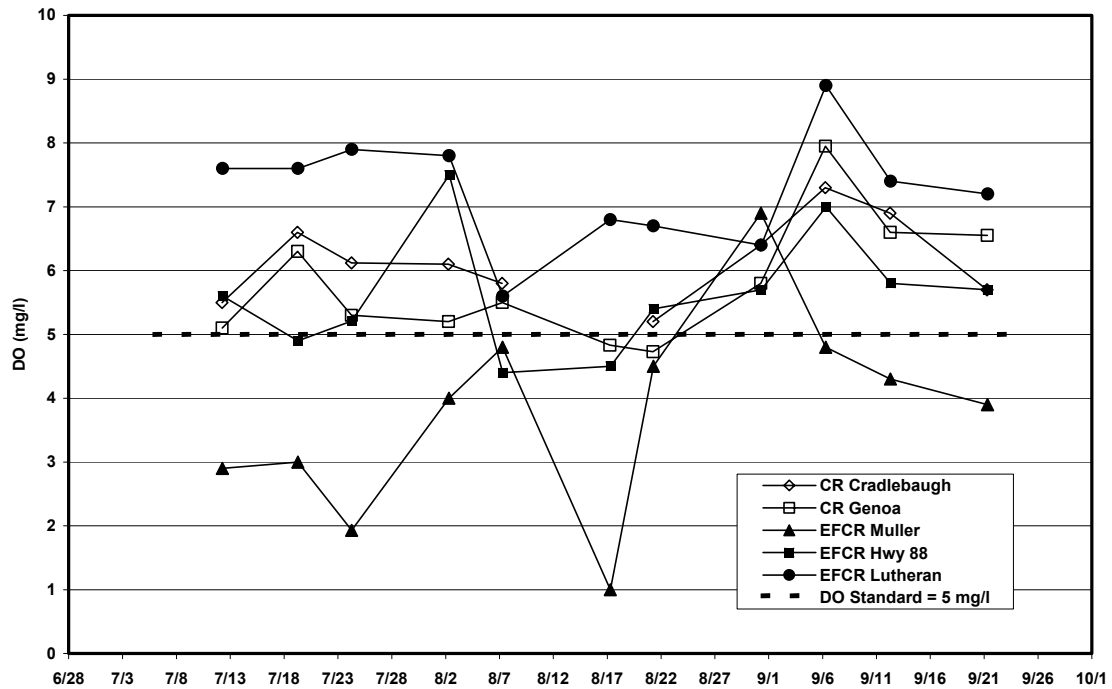
Figure 7. Early Morning DO at Spot Reading Sites - EF Carson and Carson River

As mentioned earlier, BWQP staff monitored early morning and late afternoon DO and temperature at eight other locations upstream and downstream from the Hydrolab site. Of particular interest are the early morning DO (typically the lowest of the day) and the afternoon temperature (typically the highest) readings. Figures 7 and 8 summarize the early morning DO data collected at these sites. In general, more frequent violations of the DO standard occurred at: East Fork Carson River at Muller Lane and at all of the West Brockliss Slough sites.

There are some limitations with this approach. The intent is to monitor at the appropriate time in order to capture the minimum DO levels in the morning and maximum water temperatures in the afternoon, however it can become difficult to time the spot readings to coincide with the DO and temperature extremes. The Hydrolab data collected at Carson River at Genoa Lakes Golf Course indicate that the daily minimum DO levels generally occurred before 6 AM and the maximum temperatures occurred between 2 and 3 PM. Based upon this information, it is probable that the morning DO spot readings taken between 6 to 8 AM are higher than the actual minimums experienced at those locations. However, the afternoon temperature readings taken between 2 and 4 PM are good indicators of the daily maximum temperatures for those locations.

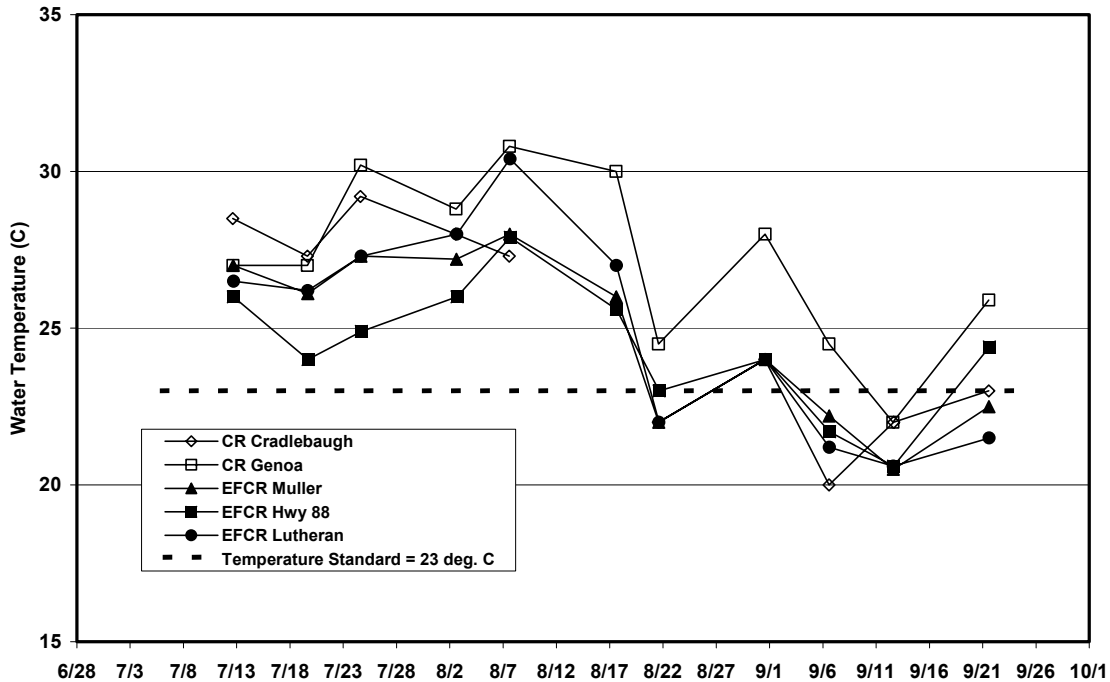
Figure 9. Afternoon Temperature at Spot Reading Sites - EF Carson and Carson River

Figures 9 and 10 present the afternoon temperature data collected at the spot reading sites. The most frequent exceedances of the temperature standard occurred during the first part of the monitoring period at the East Fork Carson and Carson River sites.
